# Mobile Intel® Celeron® Processor on .13 Micron Process in Micro-FCPGA Package

Specification Update

*December 2004*

Document Number: 251309-025

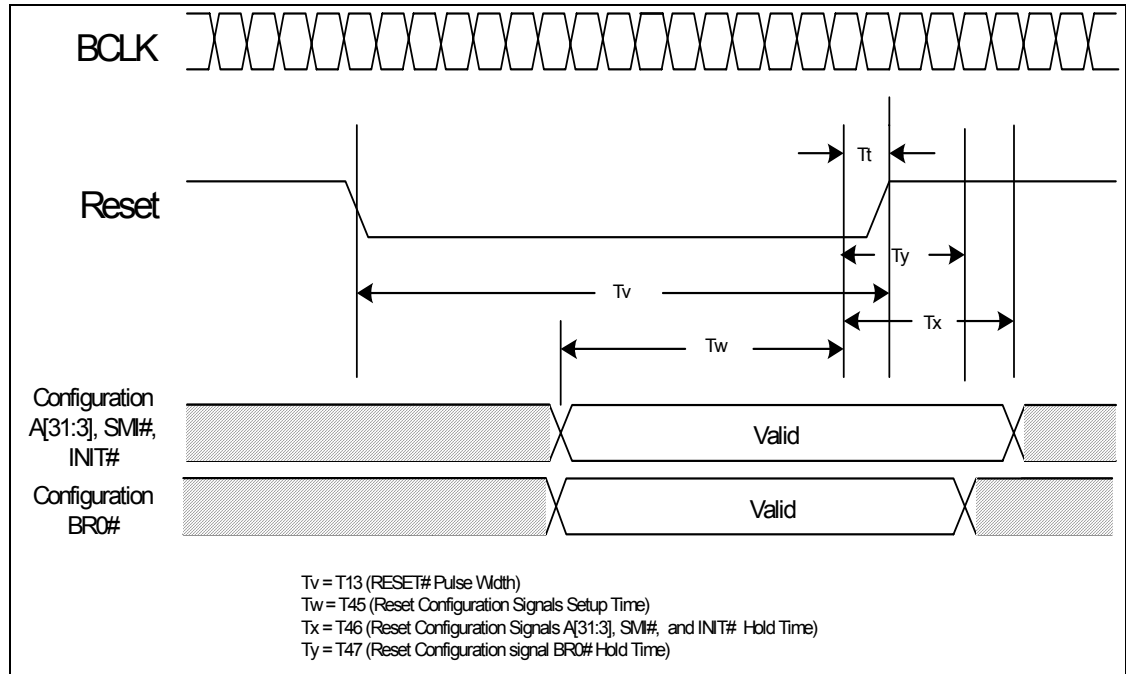
**Figure 12. System Bus Reset and Configuration Timings**

The BR0# maximum hold time has changed to 2 BCLKs. This change will be shown in the “System Bus AC Specifications (Reset Conditions)” table and “System Bus Reset and Configuration Timings” figure of the *Mobile Intel® Celeron® Processor on .13 Micron Process in Micro-FCPGA Package Datasheet*. This change will be incorporated in the next revision of the datasheet.

The following figure will be modified to reflect this change:
